# Manhole Inspection Summary

Manhole # S33I\_\_009MH

Insp Date: **3/26/08 8:50 AM**

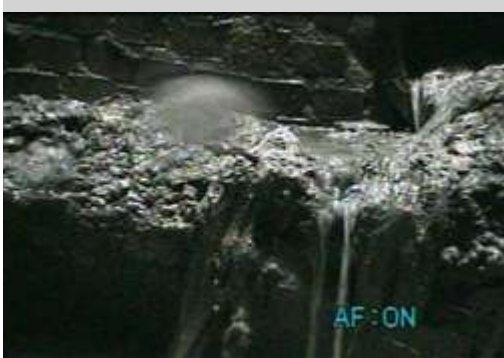
Defect 4

Condition: ☐ Sound ☐ Cracked ☐ Root Intrusion ☐ Deteriorated ☐ Leaks ☒ **Debris**

bench debris

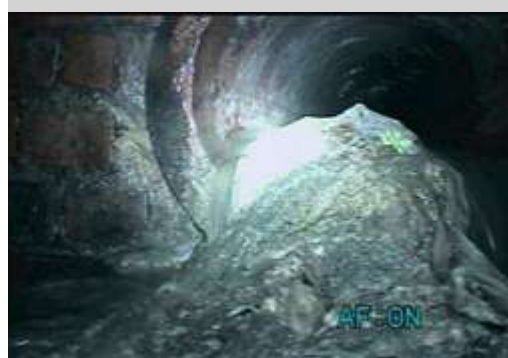
Defect 3

Condition: ☐ Sound ☐ Cracked ☐ Root Intrusion ☐ Deteriorated ☐ Leaks ☒ **Debris**

channel debris

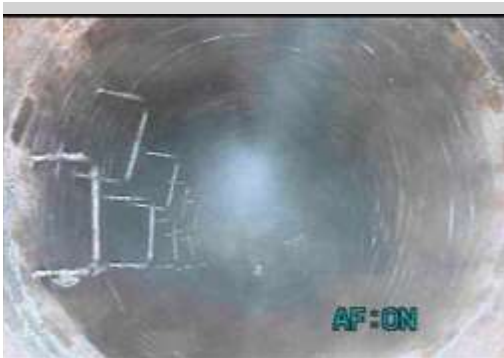
Defect 2

Count: **17** Missing: **0** ☒ **Corroded**

Corroded steps

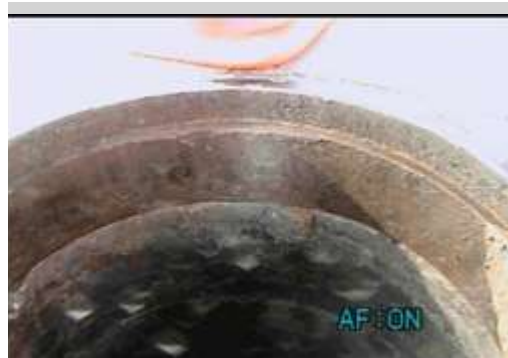
Defect 1

Condition: ☐ Sound ☒ **Cracked** ☐ Leaks

crack in frame adjustment

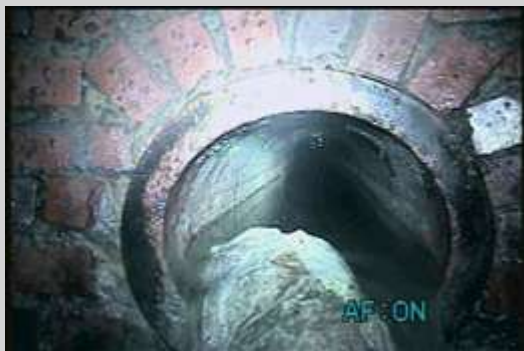
4 O'Clock Inflow

Deposits: ☐ None ☐ Mud ☐ Sludge ☒ **Debris** ☐ Grease

Silt Depth: 4 (in.) Deposits Extent: **Medium**

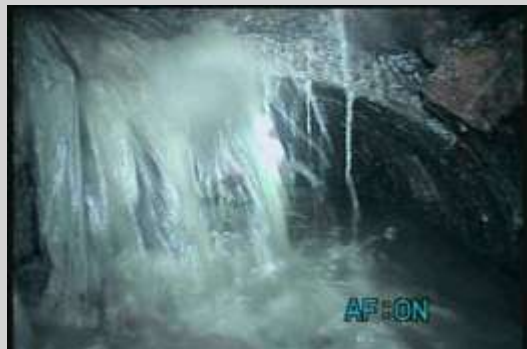
6 O'Clock Inflow

Water coming out of 4 is flowing over the bench & in front of 6
